Medicine Bow-Routt NF, Thunder Basin National Grassland North Zone Aquatics
Photo Log

Project: NFSR103 Maintenance and Restoration		
Watershed name: Brush Creek		
5 th or 6 th Hydrologic Unit Code (HUC):		
Name: E. Streeter	Date: 07/06/2016	<input checked="" type="checkbox"/> Digital <input type="checkbox"/> Film

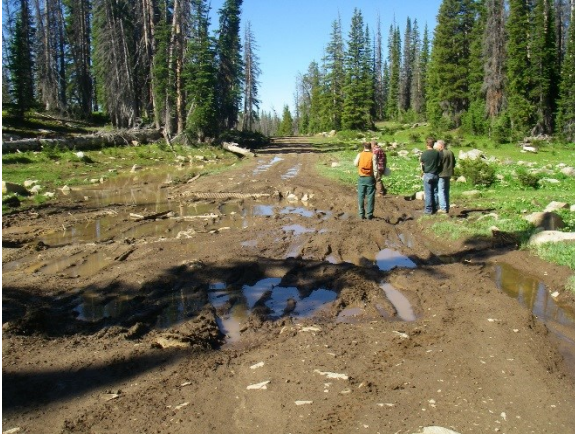
No.	Digital #	Time	UTM NAD83 Zone 13		Description
			Easting	Northing	
	IMGP0074	09:33	386373	4578204	Large mud puddle and standing water, with reroute tracks around problem area. Culvert is completely exposed and ineffective.
	IMGP0075	10:02	386655	4578440	Stream joining the road and causing reroutes.
	IMGP0076	10:03	386655	4578440	Stream joining the road and causing reroutes.
	IMGP0077	10:18	387011	4578943	Previous re-routes that were taken care of by moving trees over.
	IMGP0078	10:24	381012	4579199	Deep water crossing, causing people to re-route creating muddy tracks on both sides of the road.
	IMGP0079	10:29	381012	4579199	Deep water crossing, causing people to re-route creating muddy tracks on both sides of the road.
	IMGP0080	10:29	381012	4579199	Deep water crossing, causing people to re-route creating muddy tracks on both sides of the road.
	IMGP0081	10:44	387049	4579600	Big puddle with re-routes on the side, leading to washout below.

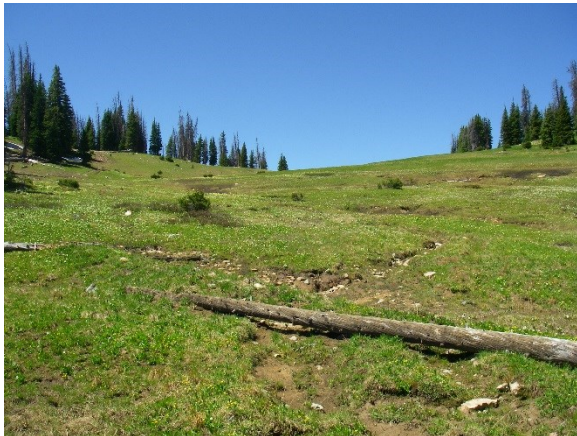
IMGP0082	11:00	387092	4579835	Big puddle causing people to re-route.
	IMGP0083	11:18	387224	4581058	Re-routes through meadow to avoid small snow drift on road.
	IMGP0084	11:18	387224	4581058	Re-routes through meadow to avoid small snow drift on road.
	IMGP0085	11:40	387718	4582646	Lots of muddy re-routes through meadow.
	IMGP0086	11:40	387718	4582646	Lots of muddy re-routes through meadow.
	IMGP0087	11:40	387718	4582646	Lots of muddy re-routes through meadow.
	IMGP0088	11:44	387718	4582646	Lots of muddy re-routes through meadow.
	IMGP0089	11:44	387718	4582646	Lots of muddy re-routes through meadow.
	IMGP0092	12:18	387798	4584433	Stream crossing with re-routes and fallen trees.
	IMGP0093	12:46	387225	4584595	Unauthorized trail
	IMGP0094	14:12	386644	4584656	Big mud puddle causing people to re-route uphill of road.
